AFRL-VA-WP-TR-2004-3109

**DEVELOPMENT OF A
MATHEMATICAL MODEL TO
PREDICT CRACKING IN CORRODED
AIRCRAFT STRUCTURES**

Final Report for 10 June 1997 – 10 June 1998

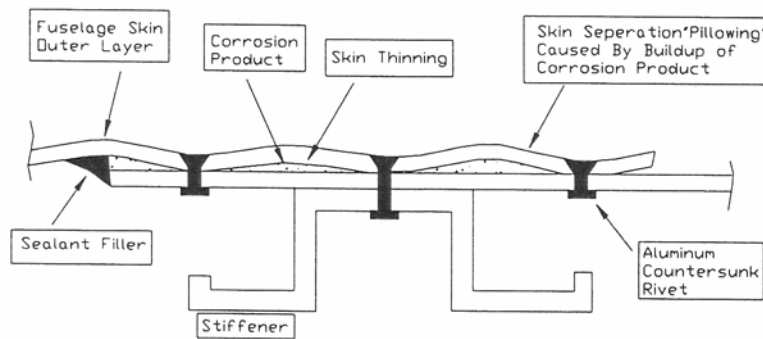
Figure 1. Cross Section through Lap Joint

Recently, much attention has been given to the phenomenon of pillowing of lap joints, where voluminous corrosion products at the contact or faying surfaces of a lap joint cause deformation of the skin, see Figure 1. Work by Komorowski and coworkers⁷⁻⁹ indicated that the volume increase associated with the corrosion products is approximately 6.5 times the volume of the corroded parent aluminum alloy. The large volume increase and resulting deformation of the skin likely results in high stresses near the fasteners, which can have a definite detrimental effect on the structural integrity of the lap joint by lowering the strength and providing preferential sites for fatigue crack initiation. Mathematical and finite element modeling by Komorowski⁷⁻⁹ were used to simulate the presence of the voluminous corrosion products within the fuselage lap joint. The stresses in the skin, which result from the internal pressure by the corrosion product build-up, from the fasteners, and from the reduction in thickness caused by material loss were all taken into account. The results of the calculations indicated that the pillowing significantly increases the stress in a fuselage lap joint, particularly in the vicinity of the fastener holes.

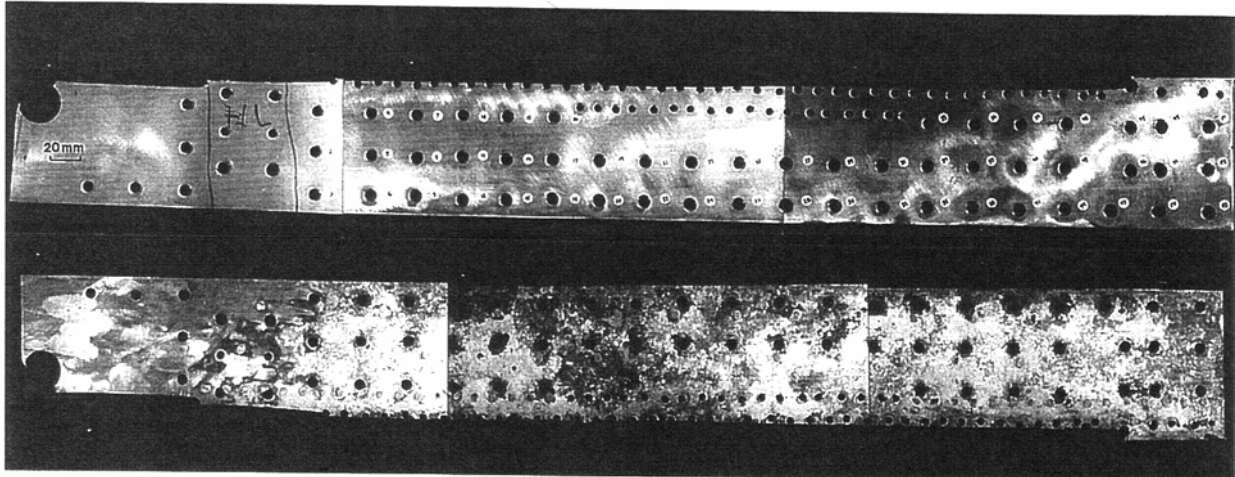
Figure 2. Contact (Top) and Outside (Bottom) Surface of KC-135 Fuselage Lap Joint

As shown in Figure 2, the outside of the lap joint showed little or no evidence of corrosion, but on the contact or faying surface of the lap joint, voluminous corrosion products (hydrated Al_2O_3 or $\text{Al}(\text{OH})_3$), which are characteristic of exfoliation corrosion, can be observed.

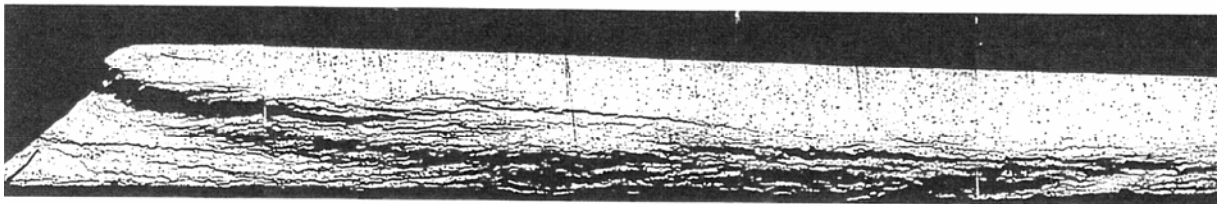
Figure 3. Metallographic Cross Section through Area Adjacent to Fastener Hole; Outside Surface is Facing Up.

Metallographic cross sections through the lap joint section, such as in Figure 3, show extensive corrosion of the aluminum alloy skin, including pitting, exfoliation corrosion and intergranular corrosion. The figures show that exfoliation corrosion can either start from the faying surface or from a fastener hole. In the latter case, exfoliation can propagate over long distances before sufficient corrosion product is built up to create the pillowing effect. Once sufficient corrosion product has formed, lifting of the grains is observed, which is characteristic for severe exfoliation corrosion. When the grains are lifted off, and surrounded by the hydrated aluminum hydroxide, corrosion of the alloy grains continues by an apparent form of dealloying corrosion.

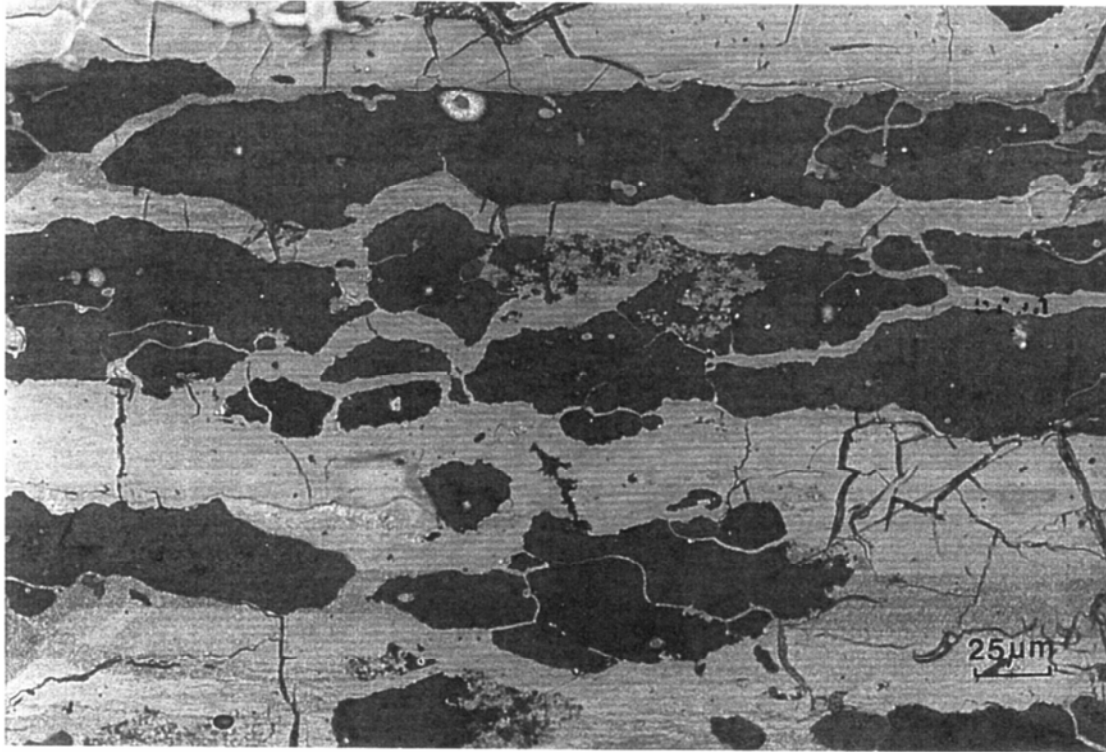
Figure 4. Metallographic Cross Section of Exfoliated Grain, Showing Preferential Dissolution of Aluminum from the Grains.

The optical micrographs of exfoliated grains, shown in Figure 4, clearly demonstrate the dissolution of the grains. Specifically, the micrograph shows remnants of the corroded grains indicating selective dissolution.

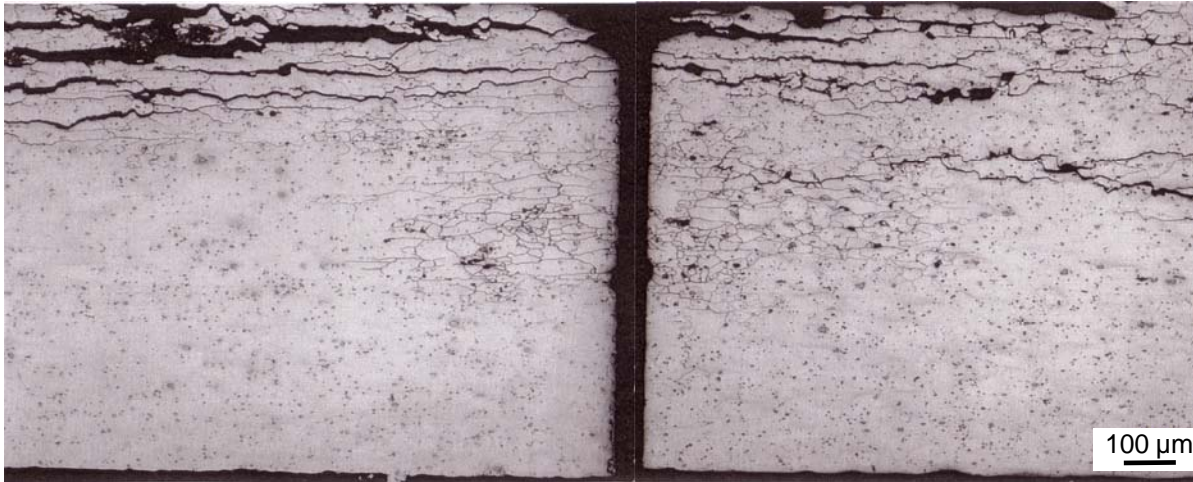
Figure 5. Optical Micrographs of Perpendicular Cross Sections Showing A Pocket of Fine Intergranular Corrosion.

Further examination of several metallographic cross sections through the lap joint section demonstrated the presence of localized regions of intergranular corrosion in the aluminum alloy skin under the exfoliated regions. The intergranular attack, which occurs along grain boundaries and subgrain boundaries, is very tight suggesting that the voluminous aluminum hydroxide corrosion byproducts has not yet formed. Perpendicular cross sections such as shown in Figure 5 suggest that these regions of intergranular attack occur in the form of approximate hemispheres, and can propagate deep into the skin. In some cases, it was found that the intergranular attack has occurred along a single path, which is characteristic of intergranular stress-corrosion cracking.

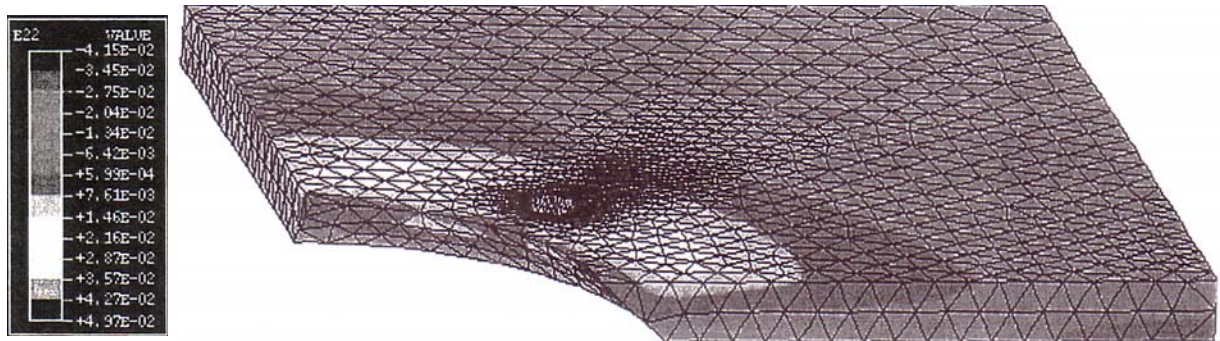
Figure 6. Finite Element Mesh of Quarter Sheet with Fastener Hole and Hemisphere with 0.46 mm (0.018 Inch) Radius and Located 5 mm (0.198 Inch) from Center of Fastener Hole.

The finite element modeling was conducted on a 38 square mm (1.5 square inch) plate section, 0.9 mm (0.036 inch) thick. The dimensions of the fastener holes, with an inner radius of 3.5 mm (0.14 inch) and outer radius of 4.5 mm (0.18 inch), were similar to those of the fastener holes in the fuselage lap joint. Because of the symmetry of the plate, one quarter of the plate was modeled using 3420 10-node tetrahedron elements. The displacement components of the fastener hole were assumed to be zero. When a uniform pressure of 1 psi was applied, the maximum normal strain in the diagonal direction of the plate was found to be 0.029 on the diagonal 5 mm (0.198 inches) from the center of the fastener hole.

In order to examine the effects of localized corrosion on the stress and strain distribution on the plate, a small hemisphere with a radius of 0.46 mm (0.018 inches) was placed on the diagonal 5 mm (0.198 inch) away from the center of the fastener hole. The location of the hemisphere was selected to coincide with the point where the normal strain in diagonal direction was the highest. With the 0.46 mm (0.018 inch) radius hemisphere, the maximum normal strain in diagonal direction is 0.0498, which occurs on the side where the hemisphere is located, see Figures 6 and 7. The strain at the location of the hemisphere is approximately 72% higher than the strain at the same location without the hemisphere. It is important to note that the calculations are based on the assumption of linear elasticity, and thus the magnitude of the maximum normal strain is well beyond the elastic range of the material.

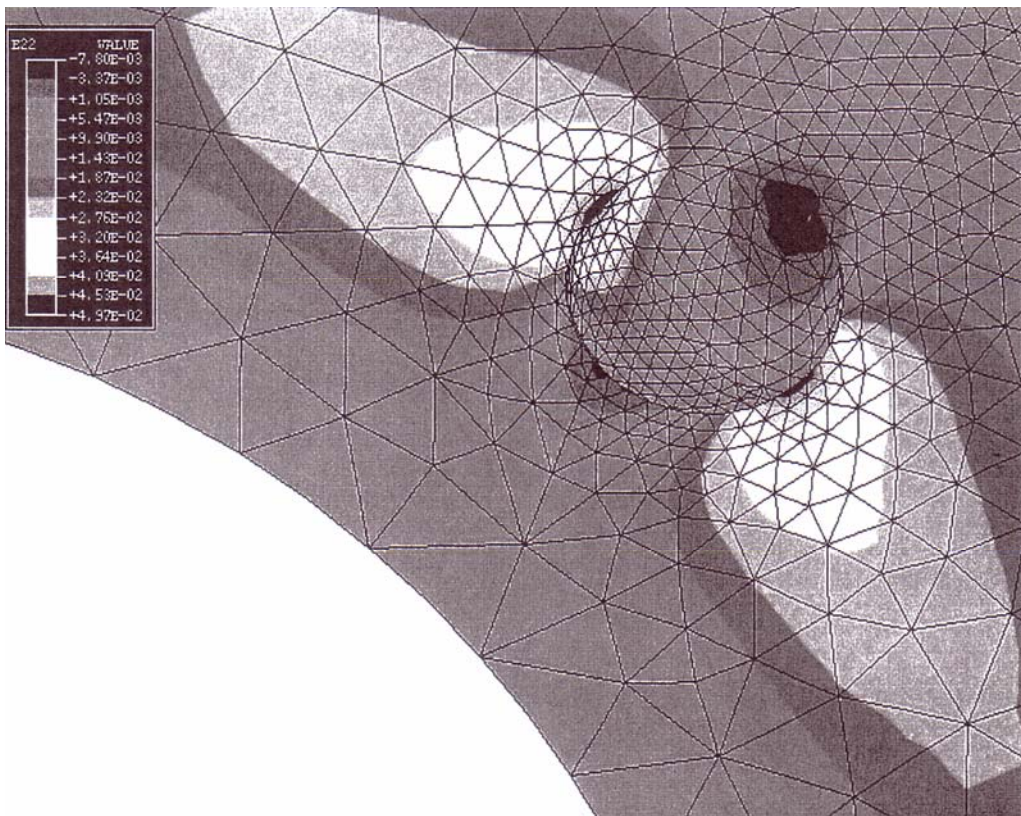
Figure 7. Local view of Strain Distribution Around the Hemisphere Shown in Figure 6.

After determining the effect of a 0.46 mm (0.018-inch) radius hemisphere on the strain distribution near a fastener hole, the effect of size of the hemisphere was investigated. When the 0.46 mm (0.018-inch) radius hemisphere was reduced by a factor of two, it was found that upon application of the 1 psi lateral pressure, the maximum normal strain was 0.053. This strain is 6.6% larger than the strain calculated for the larger hemisphere. The results of these calculations indicate that the size of the hemisphere has a significant effect on the stress-strain distribution around the hemisphere, and that there is likely to be an optimal size at which the strain is at a maximum.

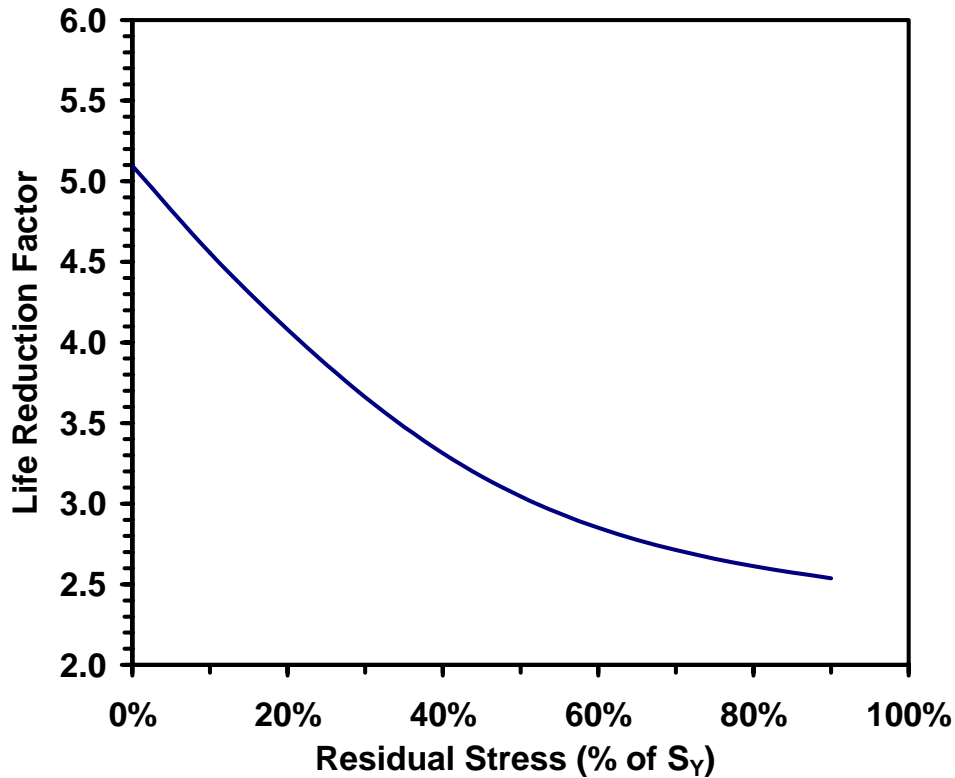
Figure 8. Reduction in Predicted Fatigue Life as a Function of Residual Stress

Not surprisingly, the strain-based fatigue life analysis predicts a significant reduction in fatigue life due to either “residual stresses” or “stress concentrations” resulting from corrosion. Combining the

contribution from each yields a further reduction in fatigue life. And while the actual fatigue life predictions shown in Table 1 and Figure 8 may not represent the actual impact on USAF aircraft, the approach outlined may help form the underpinnings of a method to better model or assess the impact of corrosion on structural integrity.
